Manhole Inspection Summary

Manhole # S39Q__019MH

Record Plat: **39Q** Node: **019** Status: **New Manhole (Not in GIS)** Insp Date: **9/16/08 12:00 AM**

Location Address: **1244 harbor island walk**

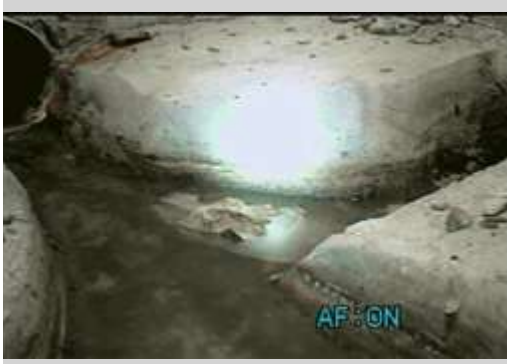
Defect 3

Condition: ☐ Sound ☐ Cracked ☐ Root Intrusion ☐ Deteriorated ☐ Leaks ☒ **Debris**

channel debris

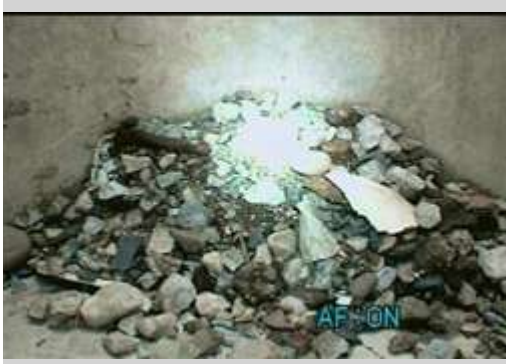
Defect 2

Condition: ☐ Sound ☐ Cracked ☐ Root Intrusion ☐ Deteriorated ☐ Leaks ☒ **Debris**

bench debris

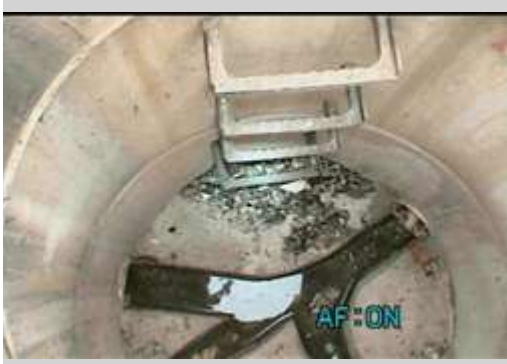
Defect 1

Count: **4** Missing: **0** ☒ **Corroded**

steps

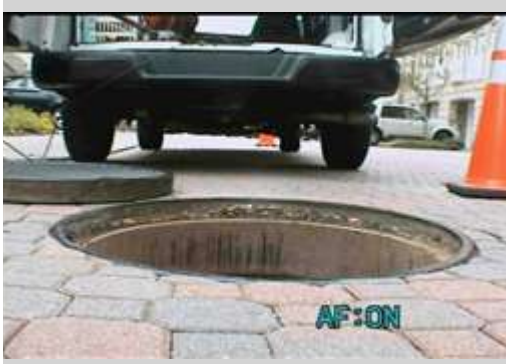
Defect 4

☒ **Leaks**

frame infiltration

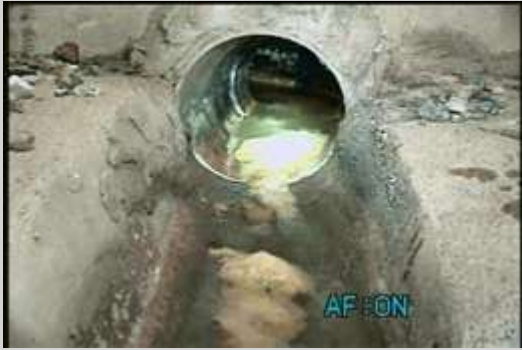
6 O'Clock Inflow

Deposits: ☐ None ☐ Mud ☐ Sludge ☒ Debris ☐ Grease

Silt Depth: **2** (in.) Deposits Extent: **Light**
